LPC# 1210500002 Marion County
Sandoval Zinc Co. - Sandoval
ILD 053 980 454
F/HRS

Expanded Site Inspection

Sandoval Zinc Company
Box 263 Smelter Road Highway 51, Sandoval, Illinois
ILD 053 980 454

April 5, 2010

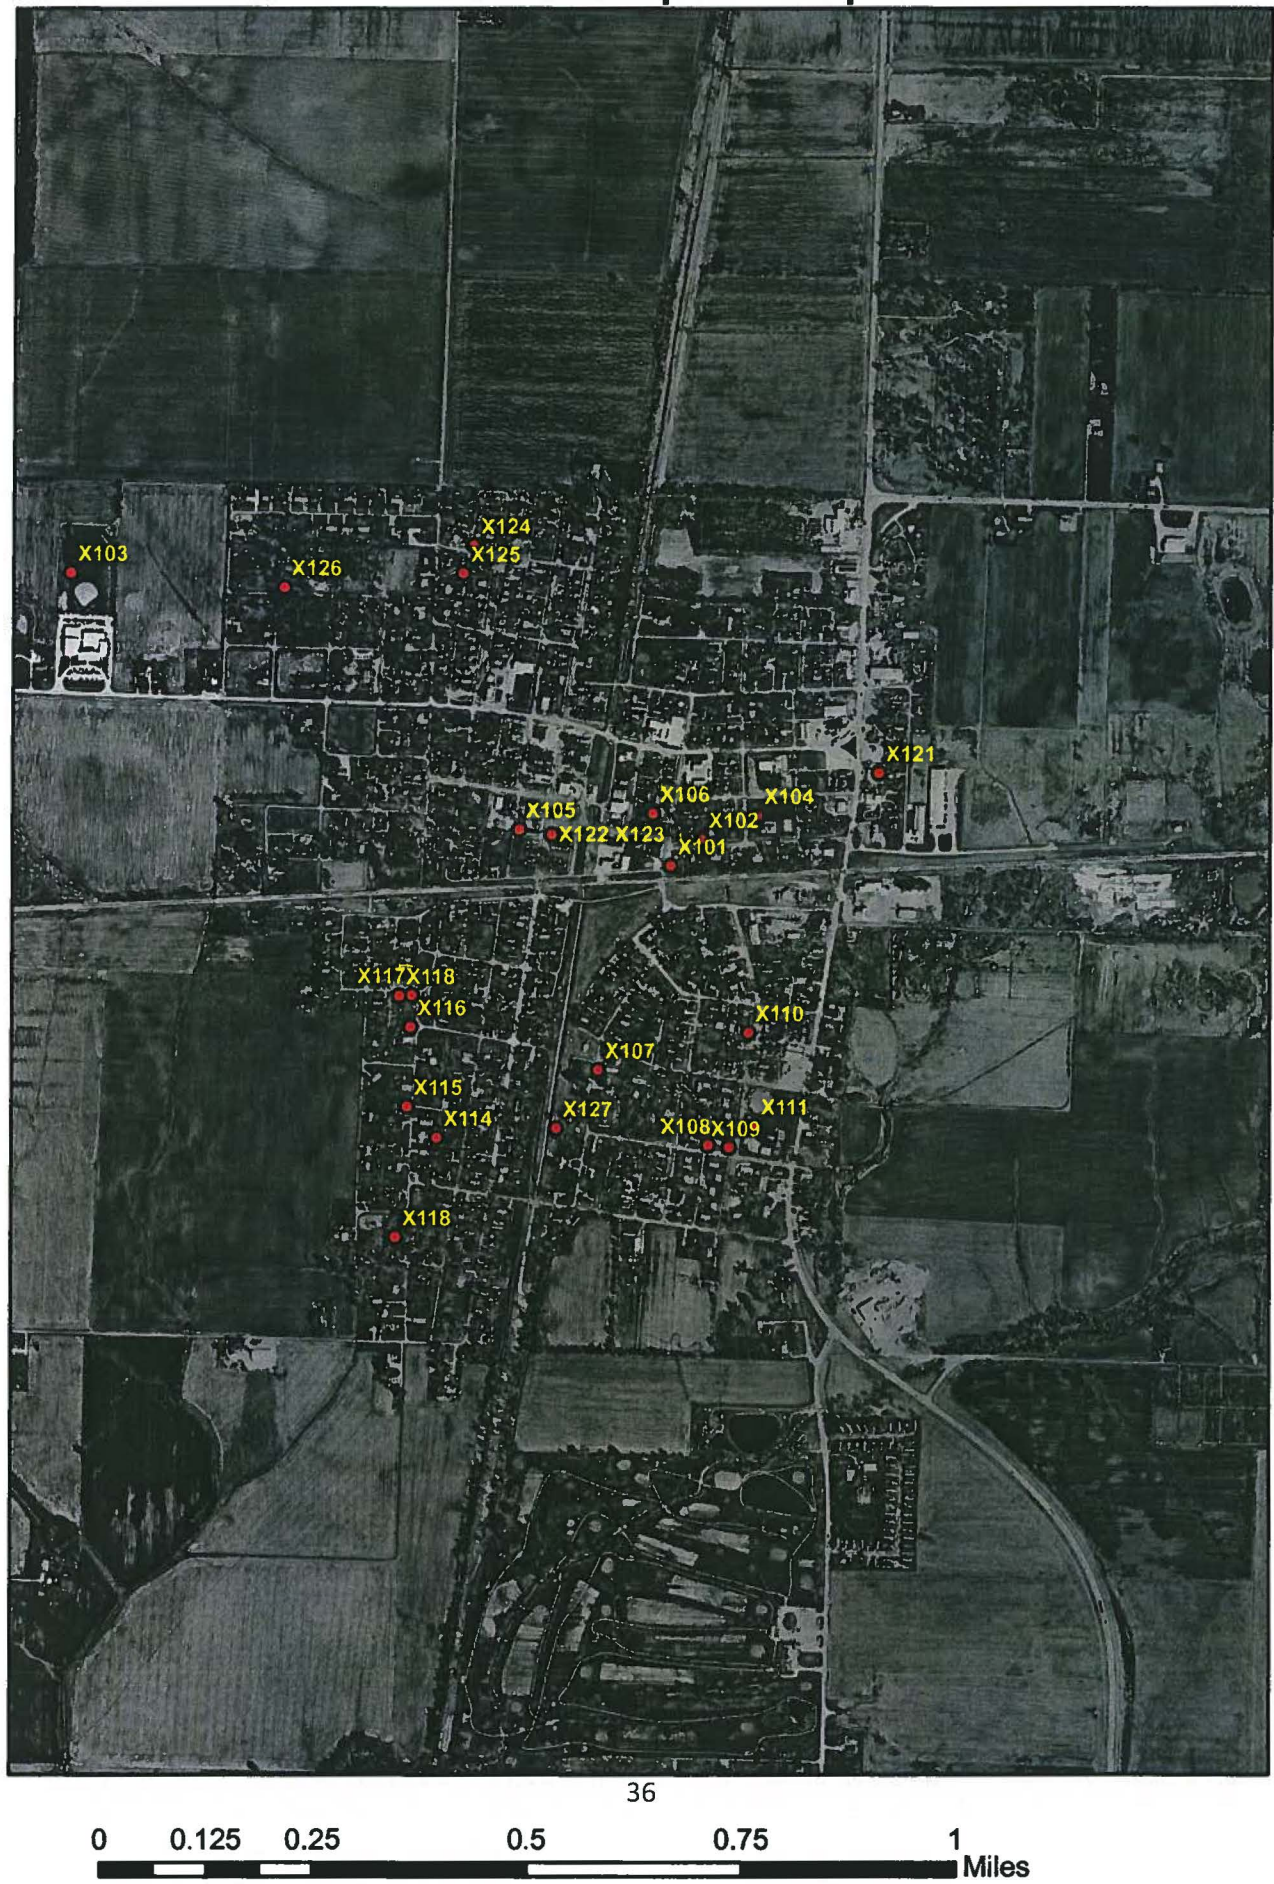
Figure 3
Soil Sample Map

The soil samples were collected with hand trowels and analyzed for the inorganic portion of the Target Compound List. All soil samples were collected within the top six inches of soil. The locations of the soil samples can be seen on Figure 3 and the complete analytical results can be seen in Table 2. Soil samples were collected following the procedures described in the Bureau of Land Sampling Procedures Guidance Manual (p. 6.7 – 6.8).

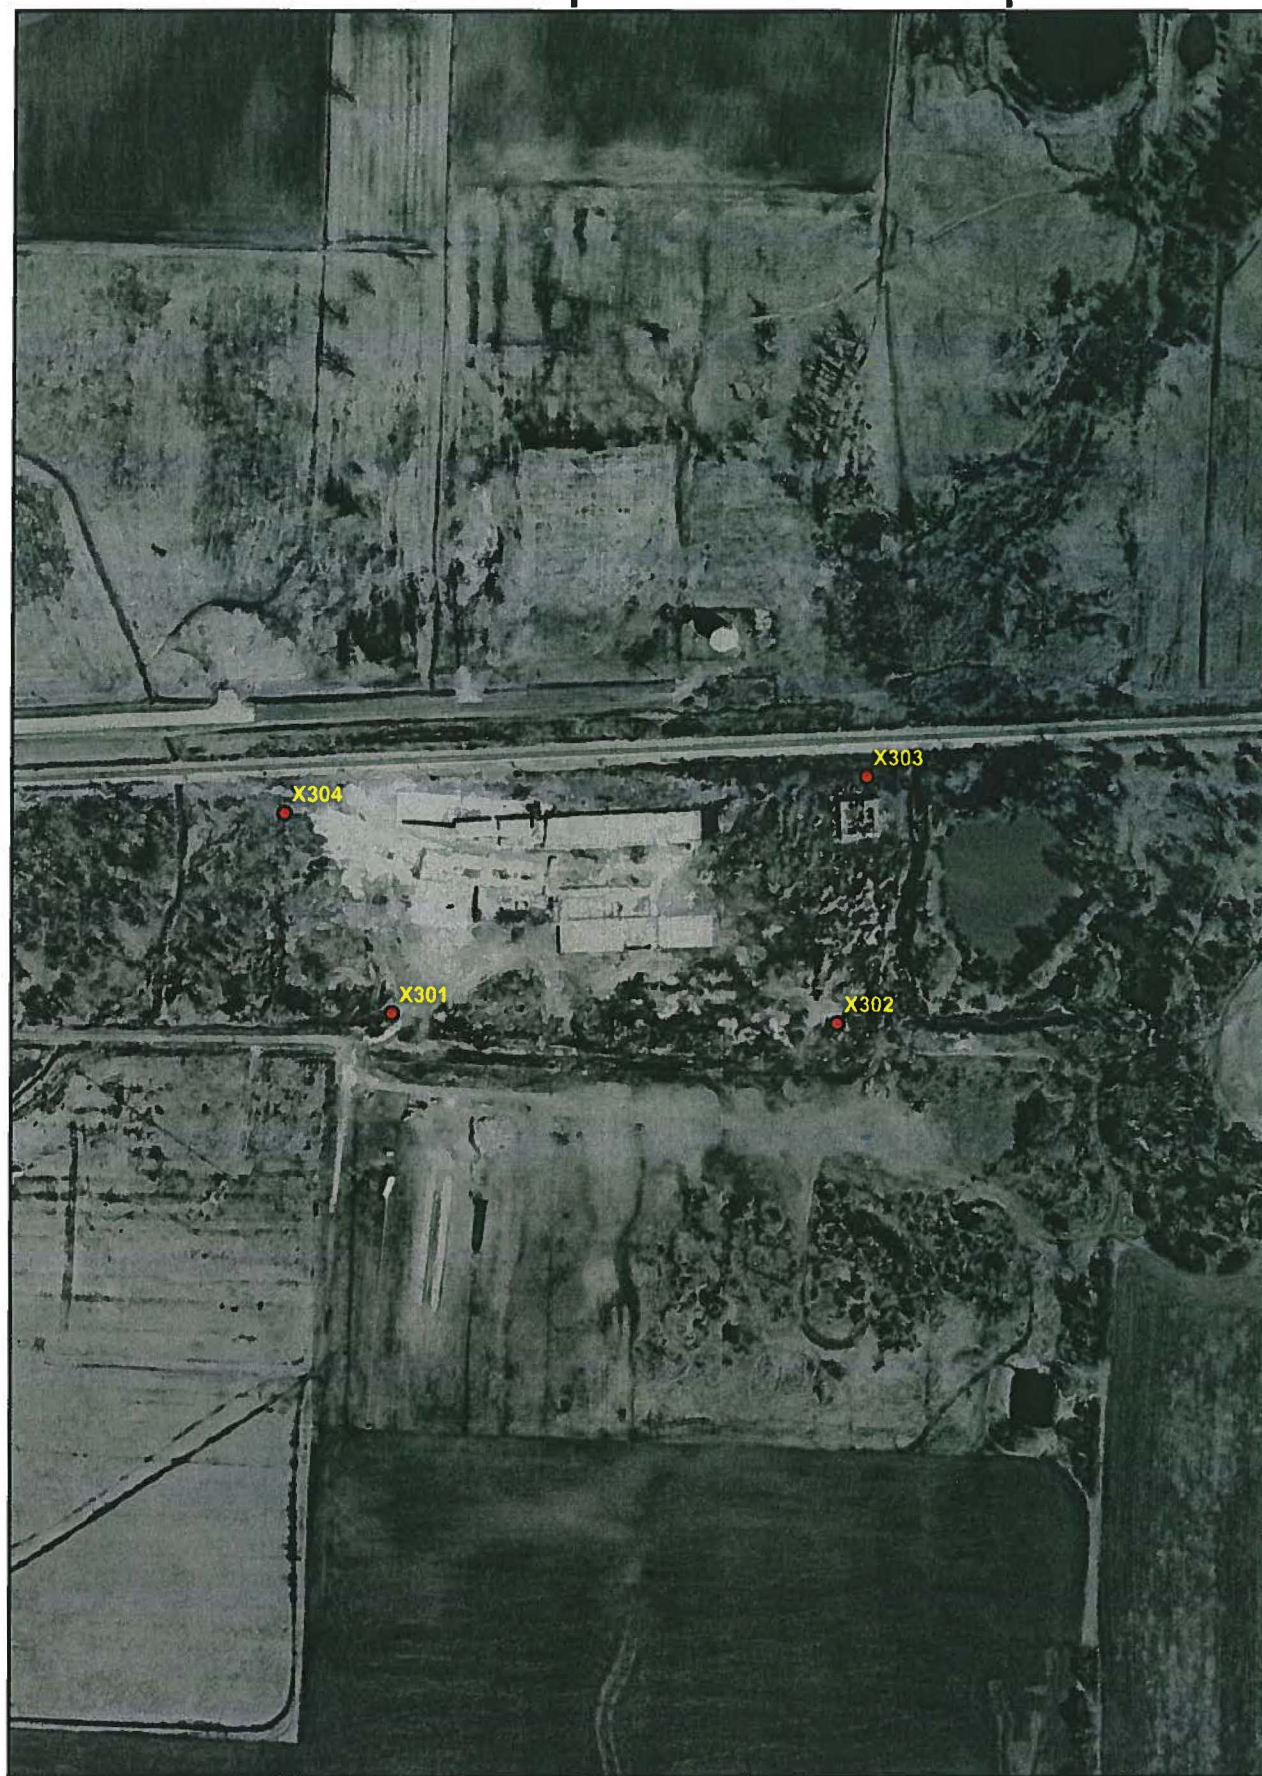
Figure 4
Waste Sample Location Map

Four samples were collected from materials located on the Sandoval Zinc property. These four samples were collected near the four corners of the site property (Figure 4). These samples were collected to help determine the levels of contamination that exist on the Sandoval Zinc property that could potentially migrate to environmental receptors. These samples were

collected with hand trowels and were analyzed for the inorganic portion of the Target Compound List. The locations of the waste samples can be seen on Figure 4 and the analytical results can be reviewed in Table 3. Waste samples were collected following the procedures described in the Bureau of Land Sampling Procedures Guidance Manual (p. 5.7 – 5.8).

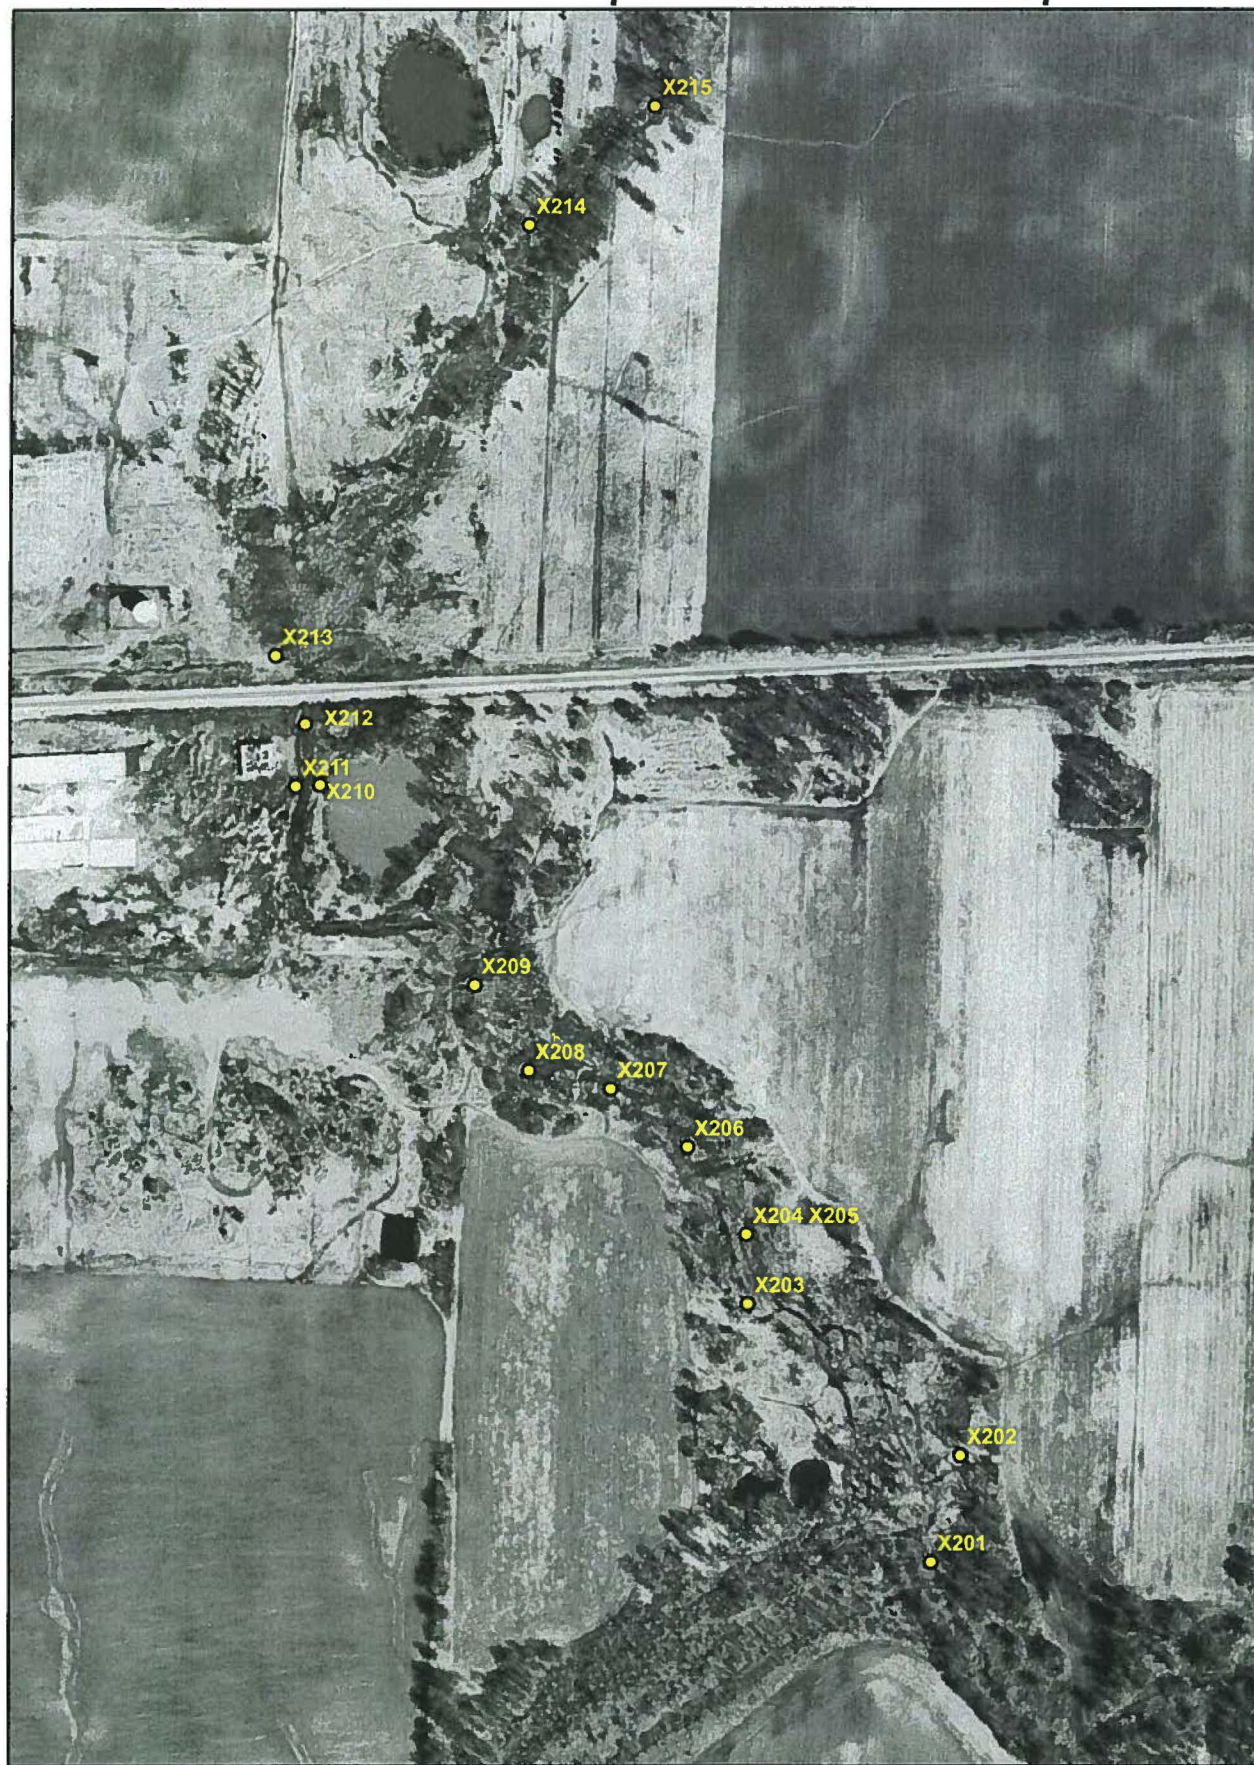
Figure 5
Sediment Sample Location Map

In October 2009, fifteen sediment samples were collected from the drainage area to the east of Sandoval Zinc in order to determine if contaminants may have migrated from Sandoval Zinc into the adjacent pond and wetlands. These samples were analyzed for the inorganic portion of the Target Compound List. All sediment samples were collected with a hand auger from the top six inches of sediment. The locations of the sediment samples are depicted in Figure 5 and the analytical results can be seen in Table 4. Sediment samples were collected following the procedures described in the Bureau of Land Sampling Procedures Guidance

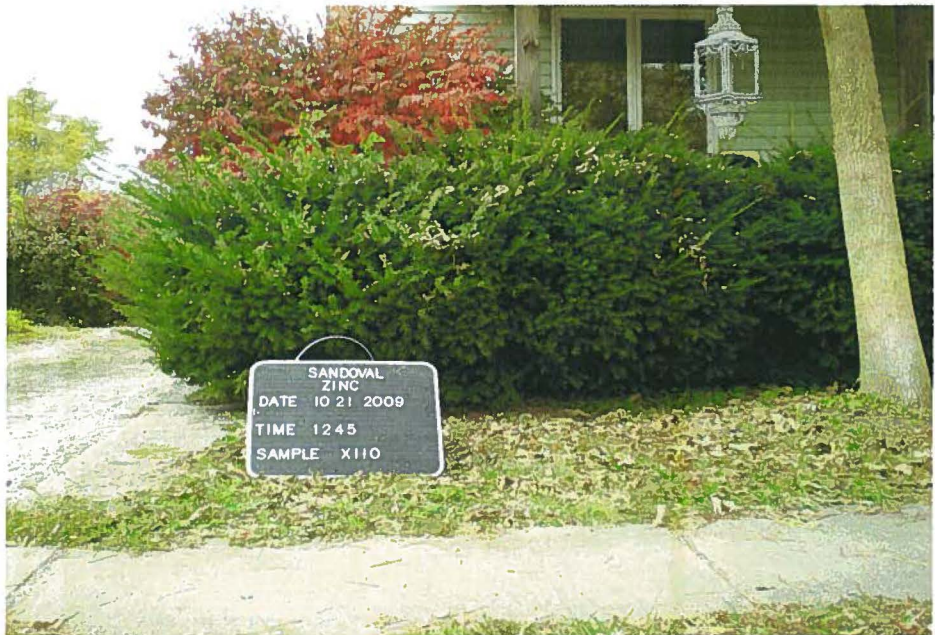
DATE:	10/21/09
TIME:	1245
PHOTO BY:	L. Range
DIRECTION:	West
COMMENTS:	X110 was collected from a residence located along Mulberry Street from the front yard. X110 consisted of a brown silty loam from a depth of 4 to 6 inches.

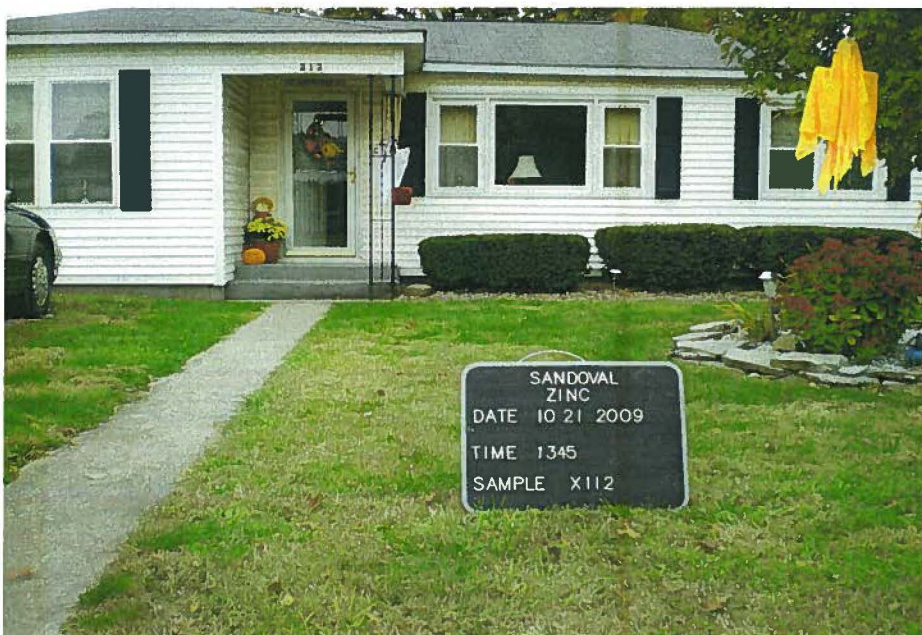
X112 was collected from a residential property located along Mulberry Street. X112 consisted of a brown silty loam with cinders from a depth of 4 inches. This sample was collected from the front yard.

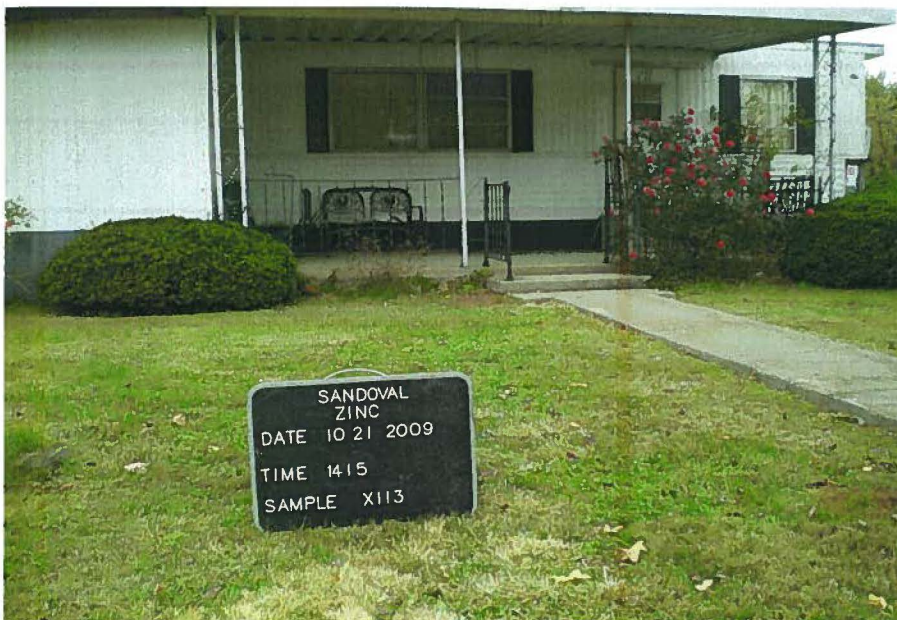
Photo was taken of sample X113. X113 was collected from a residential yard located on Arizona Street. X113 consisted of a brown silty clay with cinders from a depth of 6 inches.
